# Chivor II Penstock Life Extension Project

Extensión de vida útil de la  
conducción Chivor II

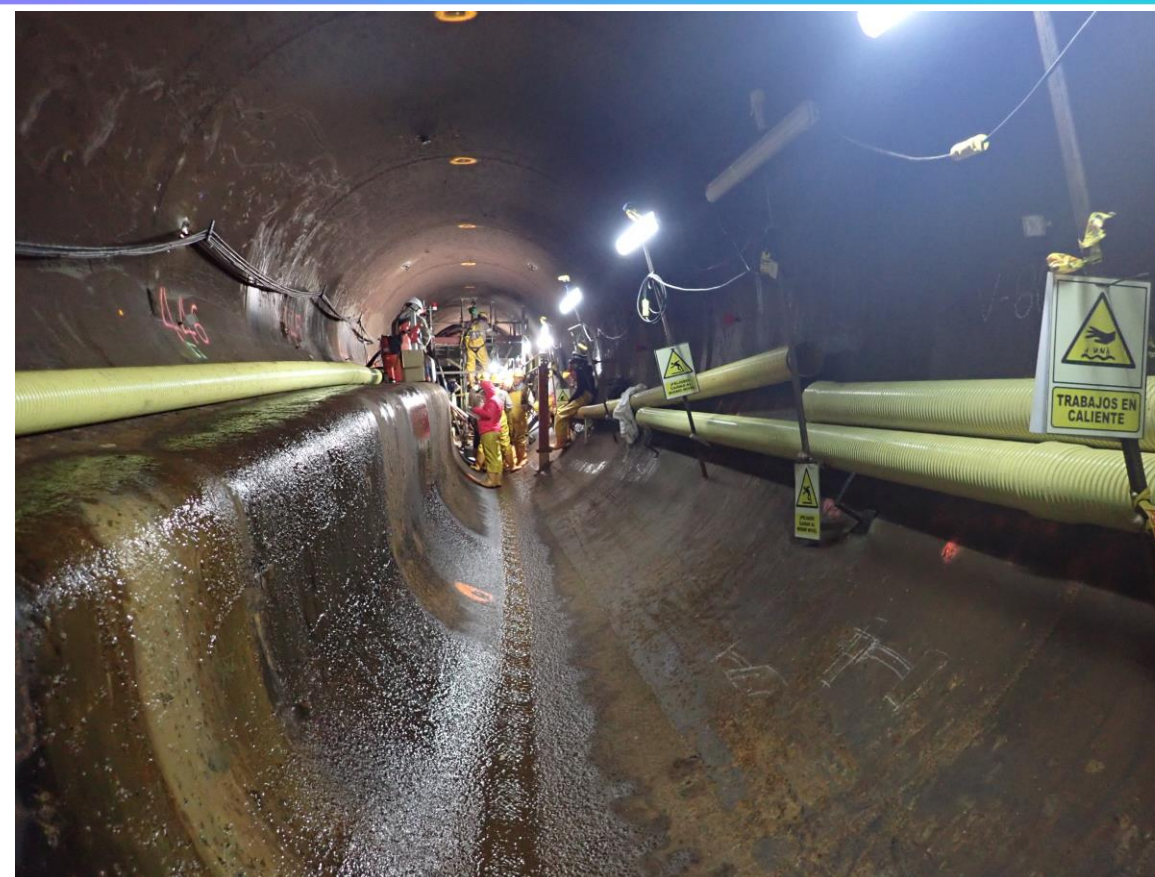
PANDEO II – CHIVOR II (25 m)

- Since the year 2000, AES has been assessing the state of the pipelines and the Buckling II zone in order to ensure the stability of the conduction tunnels. In the year 2000 Chivor II was emptied during a scheduled maintenance, and all butterfly valves were replaced or repaired, the gravel trap of the tunnel was cleaned, and a new steel pipe was installed as a liner in a 19.8-m section within a zone surrounded by limestone.

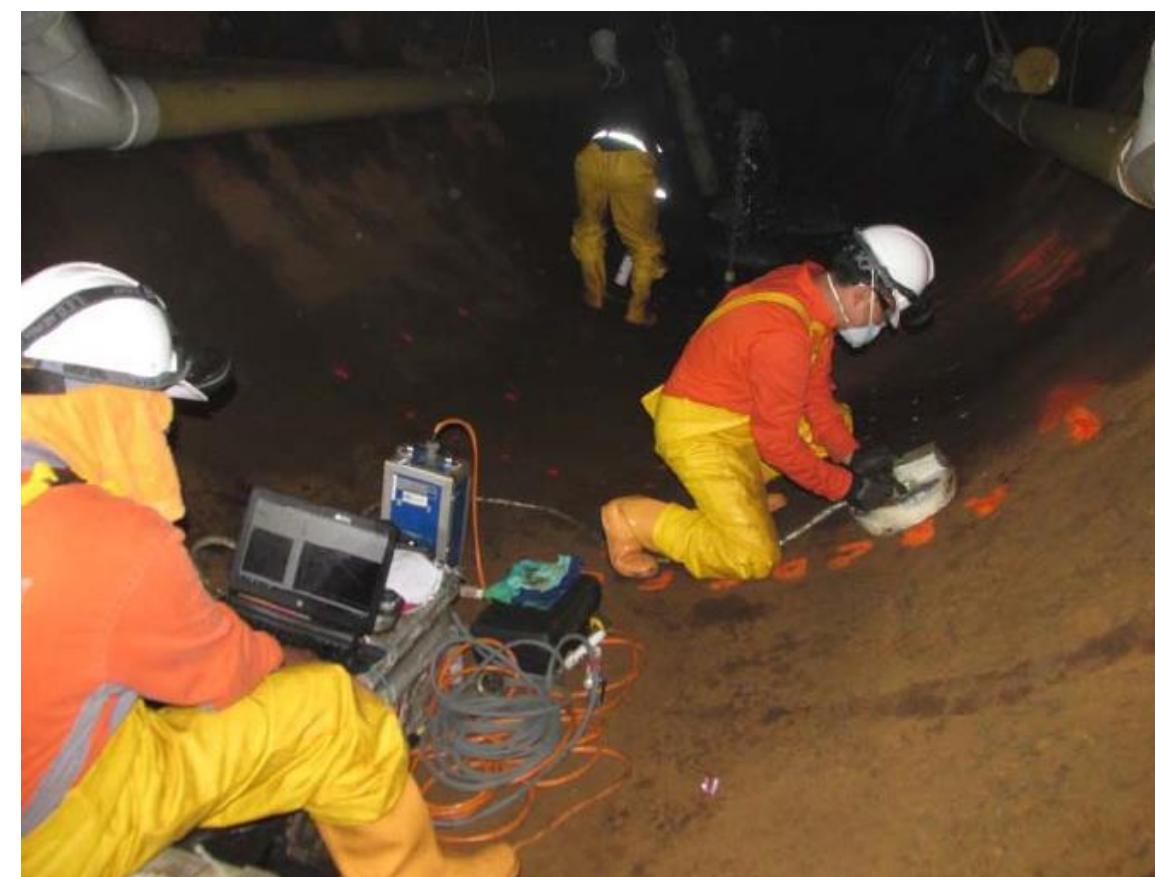
INCOTEST MEASUREMENTS

- By 2015, thickness-loss evaluation continued and plates 54 to 129 were replaced; this is equivalent to 602.8 m<sup>2</sup> of sacrificial material to keep the tunnel operating. In the same year, an Insulated Component Test (InCoTest), that uses the pulse eddy current method, and that is considered one of the most reliable corrosion detection method, was performed to eight of the plates allowing determining the percentage of volumetric material loss in the inspection area (6-inch grids in this case).

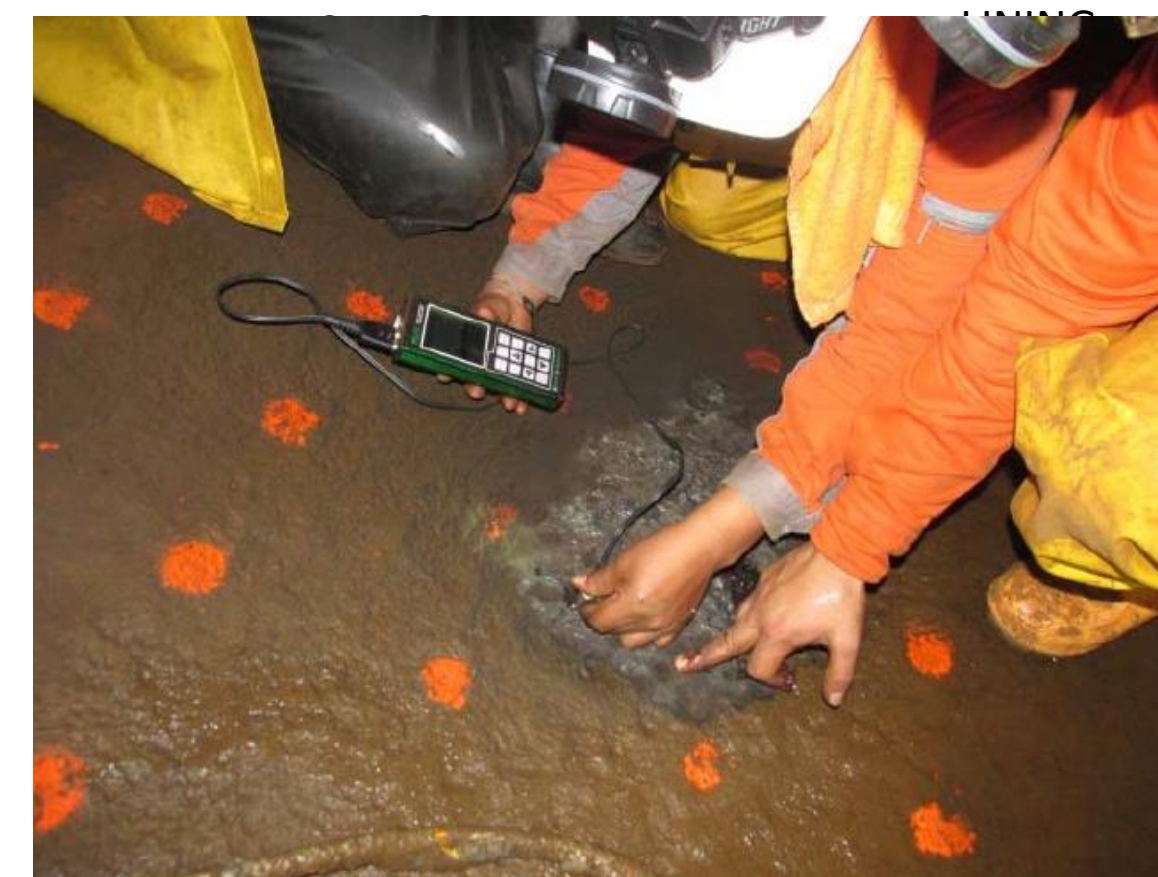
VERIFICATION BY UT

- The headrace tunnel was emptied again in 2014 and the intervention was centered on replacing relief valves and measuring the thickness of shield plates using ultrasound, which evidenced a 50% loss in thickness for 24 of the plates; hence, A36-steel 6-mm sacrificial plates were installed on plates 1 to 53, equivalent to 329.9 m<sup>2</sup>.

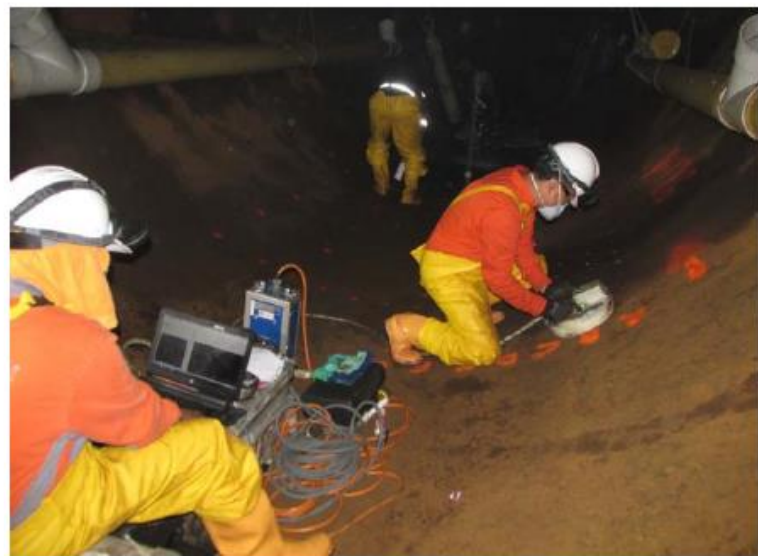
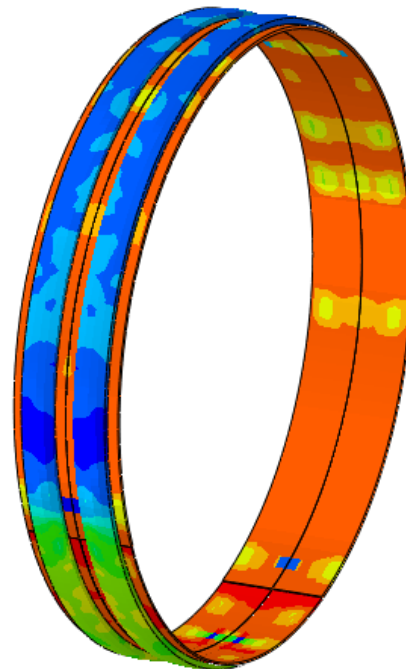
## 2015: Penstock Evaluation – PURE TECHNOLOGIES

- Ultrasound Log Data 2015.
- 59% of the pipe sections are exposed to stresses exceeding the yield point.
- More than 50% of the pipe sections have as projected useful life of less than 20 years.
- 367 Sections (3m) for change.

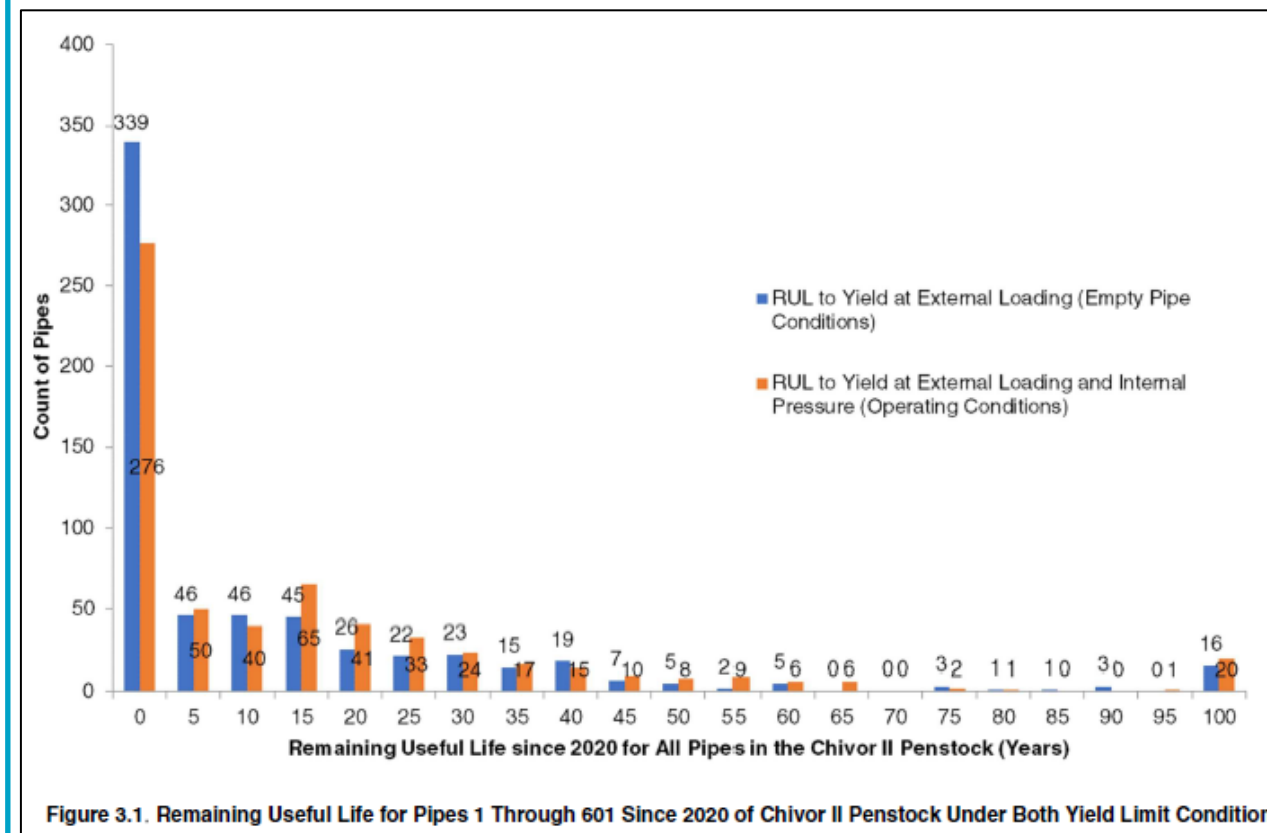
## 2020: RLA – PURE TECHNOLOGIES

- Ultrasound Log Data 2020.
- Deterioration Rate = 1,35 mm/y
- 381 Sections (3m) with less than 5 years of residual life (73%)
- 146 Sections (3m) with less than 20 years of residual life (27%).

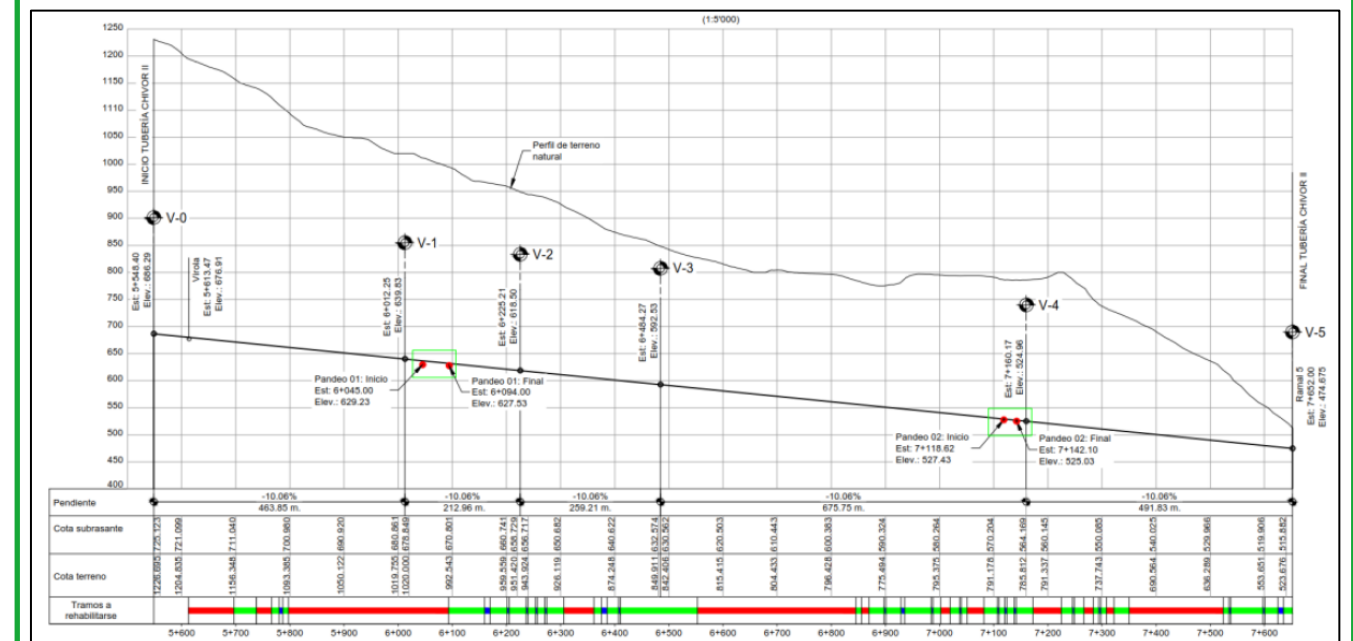
## 2021: RLA – LSH CONSULTING ENGINEERS

- Ultrasound Log Data 2015 / 2020.
- Deterioration Rate = 1,35 mm/y
- 155 Sections (3m) with less than 7,2 years of residual life (26%).
- 67 Sections (3m) with less than 9,1 years of residual life (11%).
- 379 Sections (3m) with less than 40,1 years of residual life (63%).
